Bleacher Safety

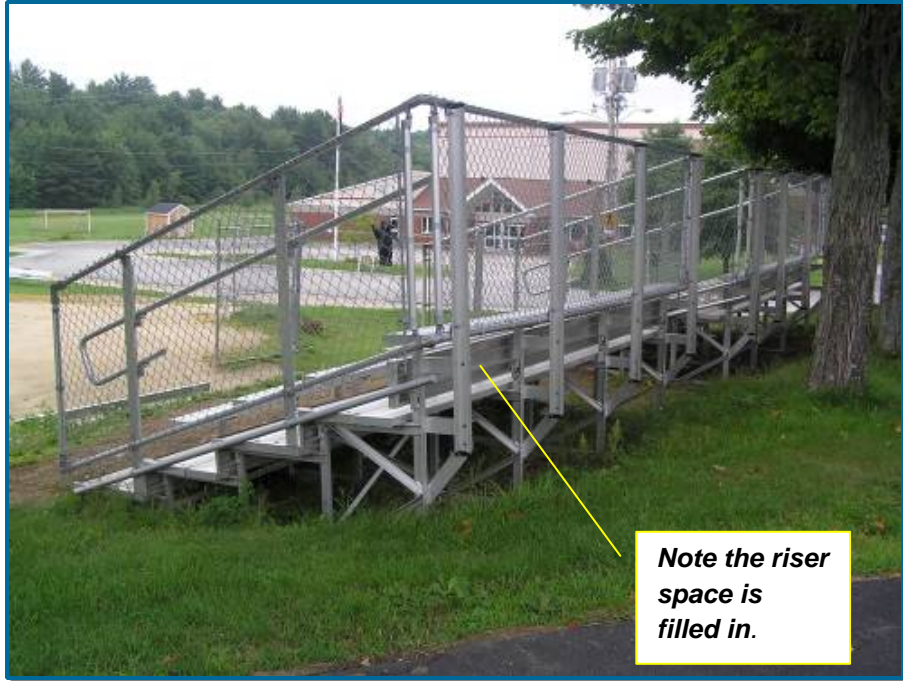
Photo shows a small, fixed or portable unit.

Note the mesh fencing on the side and back.

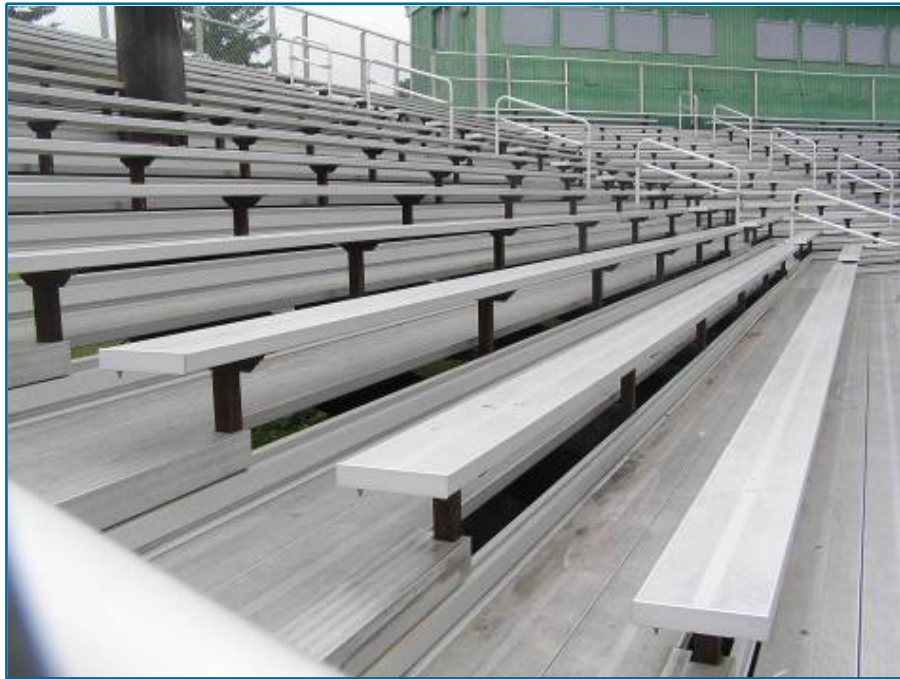
This is an older, permanent bleacher system at a high school football field. This system has been retrofitted to some degree. There is no riser fall protection and no hand rails in the aisle walkway. However, fencing has been added to the top and sides reducing the potential for falls from the bleachers. Riser gaps should be closed to reduce the potential for falls between the seat and walking surfaces, especially for children. The installation of aisle railings is recommended.
